**Flood Control Project Maintenance  
Levee Inspections**

## 2013 Channel Summary Report

## Merced Streams Group

**Flood Control Project Maintenance****Unit Cover Sheet****2013 Channel Inspection Results****Merced Streams Group**

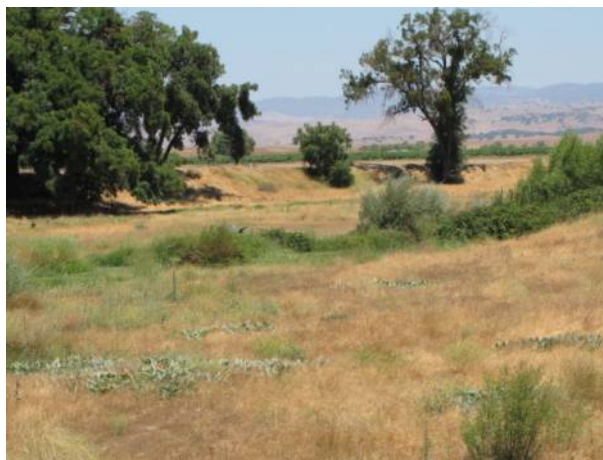
Levee Mile Report Line	1
Start Levee Mile	0.00
End Levee Mile	0.00
Location	
Category	Channels
Item	Vegetation & Obstructions
Looking upstream from Bonner Rd bridge crossing the Bear Creek. Photo taken 7-18-2013.	
phillips_c_20130807_104.JPG

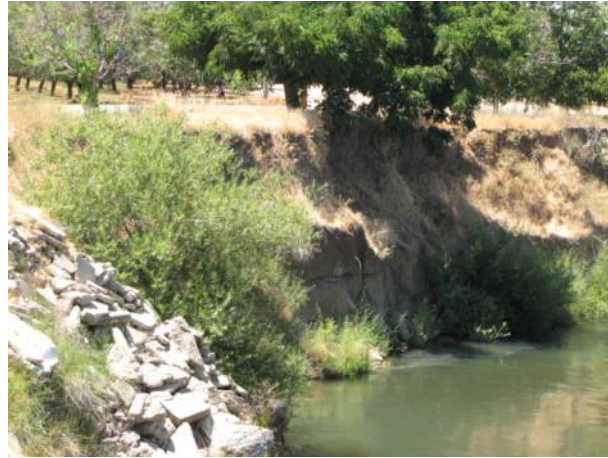
Downstream frm Kibby Road bridge crossing left bank the erosion hasn't been repaired. Photo taken 7-18-2013.

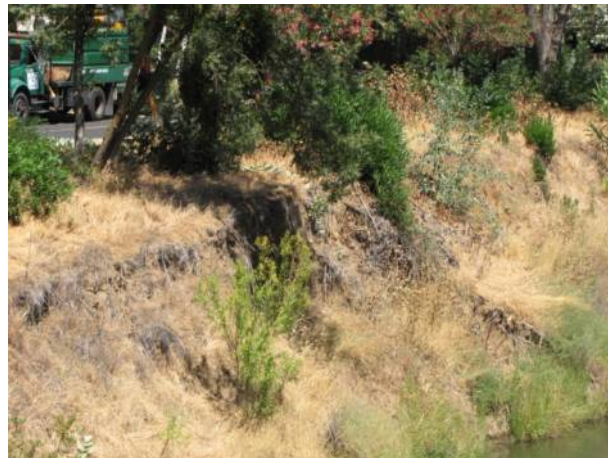
Levee Mile Report Line	33
Start Levee Mile	0.00
End Levee Mile	0.00
Location	
Category	Channels
Item	Erosion / Bank Caving

Looking upstream right bank erosion reported last inspection not repaired. Photo taken 7-18-2013.

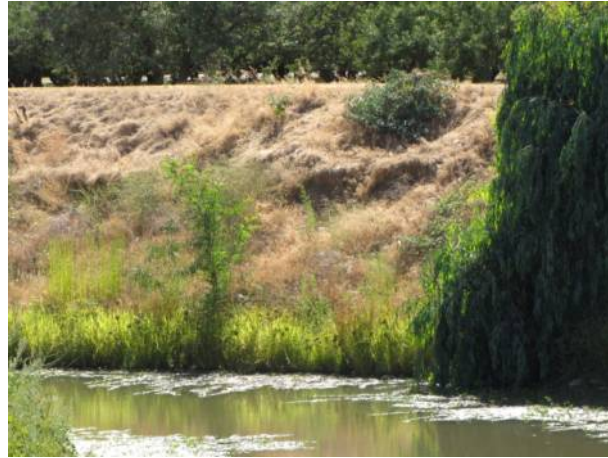
Levee Mile Report Line	58
Start Levee Mile	0.00
End Levee Mile	0.00
Location	
Category	Channels
Item	Erosion / Bank Caving
Erosion noted on right bank downstream of the bridge. This is not a new erosion site. Photo taken 7-18-2013.	
phillips_c_20130819_120.JPG

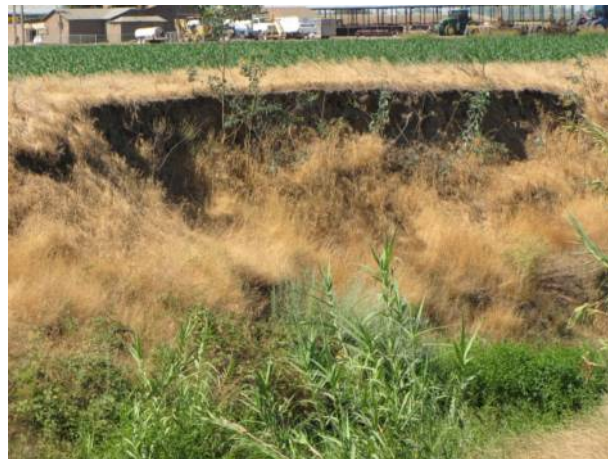
Levee Mile Report Line	87
Start Levee Mile	0.00
End Levee Mile	0.00
Location	
Category	Channels
Item	Erosion / Bank Caving

Bear Creek erosion on left bank downstream from Dickerson Ferry, this site has been reported in the past. Repairs should be done immediately. Photo taken 7-18-2013.

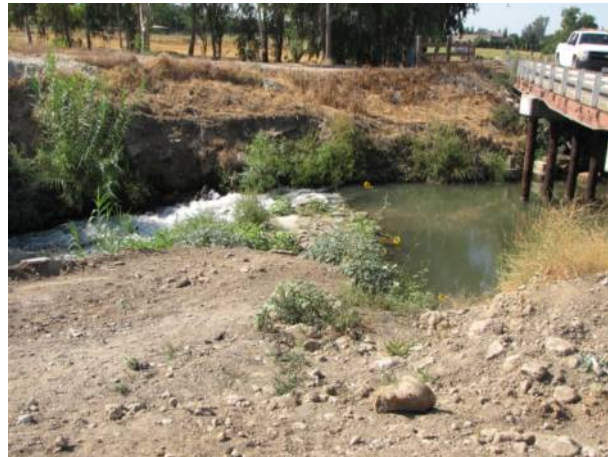
Levee Mile Report Line	60
Start Levee Mile	0.00
End Levee Mile	0.00
Location	
Category	Channels
Item	Encroachments

There is an earthen dam pushed across channel diverting flow, this dam has caused damage to the right bank. Photo taken 7-30-2013.

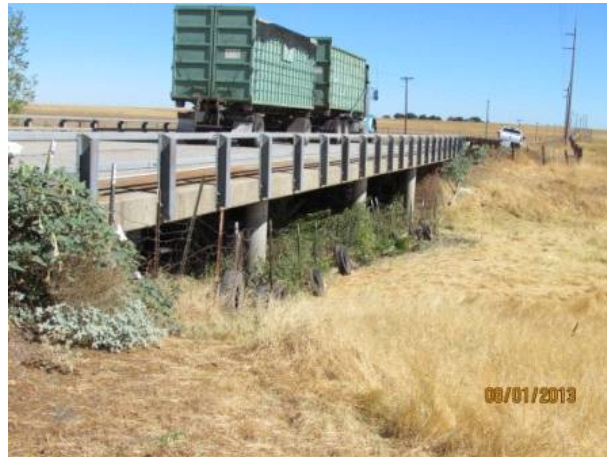
Levee Mile Report Line	5
Start Levee Mile	0.00
End Levee Mile	0.00
Location	
Category	Channels
Item	Encroachments
Wire fence on upstream side of Cunningham crossing.	
mkhashch_c_20130805_042.JPG

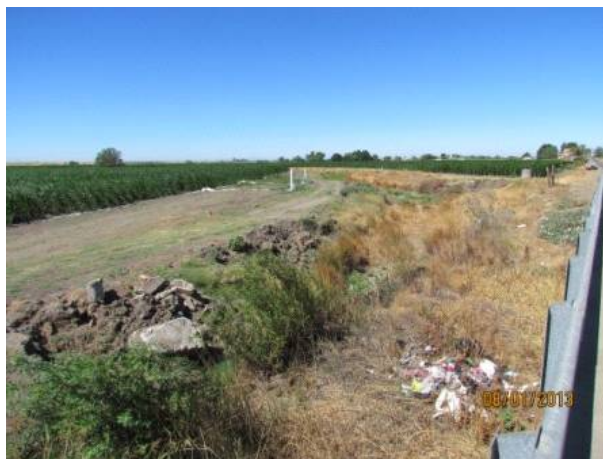
Levee Mile Report Line	18
Start Levee Mile	0.00
End Levee Mile	0.00
Location	
Category	Channels
Item	Erosion / Bank Caving

View of the repaired erosion sites.
